Climate Change Pilot Study Criticality- Structure Assessment

Structure: 05417

Location: Morris

Criticality Ranking: 8

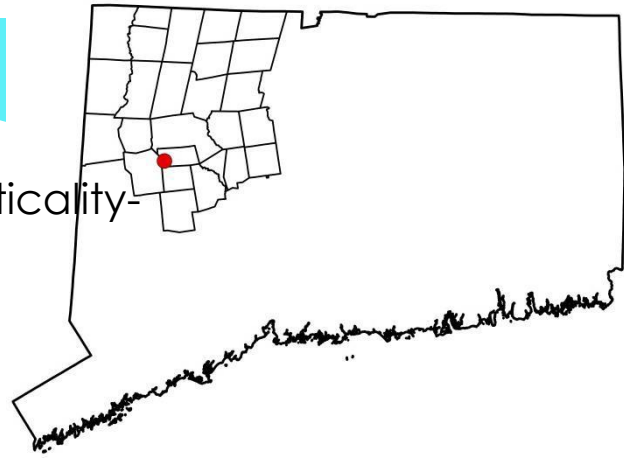
Structure 05417 is located on Route 109 over an unnamed brook in Morris. The hydraulic evaluation indicates that the structure can convey the estimated 100-yr frequency design event flows, however during the check storm event the structure does not have one foot of freeboard before reaching overtopping condition. Because the structure does not have adaptive capacity, is located within a 100 year FEMA flood zone, and is nearby several scour critical structures, it is considered to be climate critical.
